# Manhole Inspection Summary

Manhole # S35U\_\_041MH

Insp Date: **3/18/08 2:23 PM**

**Location** Address: **1439 e fort ave**

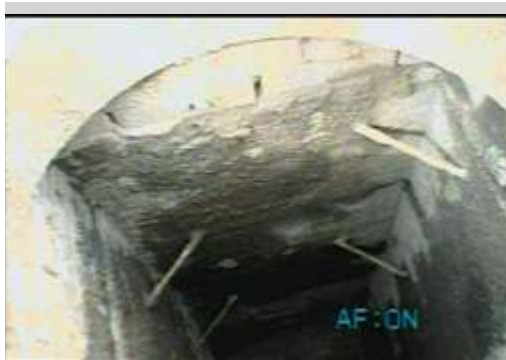
Defect 3

Count: **5** Missing: **0** ☒ Corroded

corroded stairs

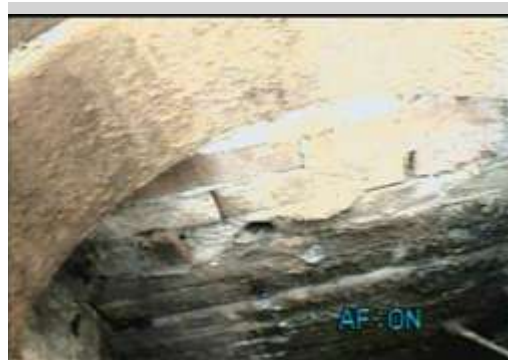
Defect 2

Offset: **3.5** (in.)

frame offset

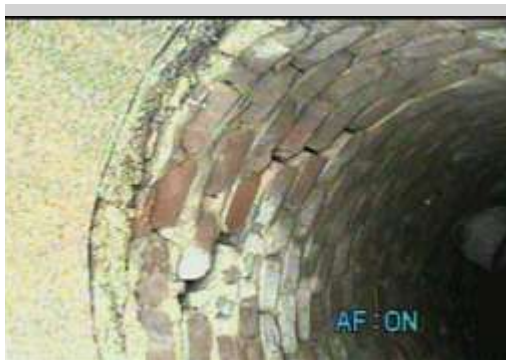
Defect 1

☒ Exists Material: **Brick and Concrete** ☐ Parged Height: **6** (in.)

Condition: ☐ Sound ☐ Cracked ☐ Root Intrusion ☒ Loose Brick ☒ Deteriorated

chimney cond deteriorated

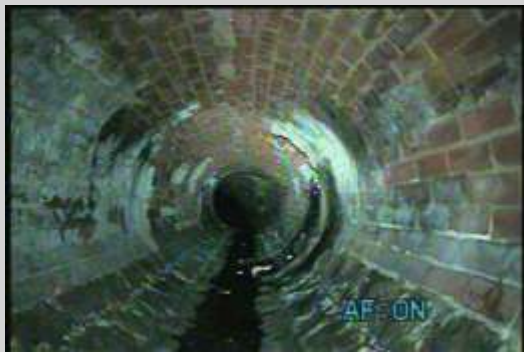
12 O'Clock Outflow

30 in. Circular Gravity Sewer  
Pipe Out @ 12 O'Clock

Pipe Material: **Unknown** ☐ Pipe Lined

Invert Depth: **9.50** (ft.) Flow Characteristics: **Slow**

Deposits: ☒ None ☐ Mud ☐ Sludge ☐ Debris ☐ Grease

Infiltration: **None**

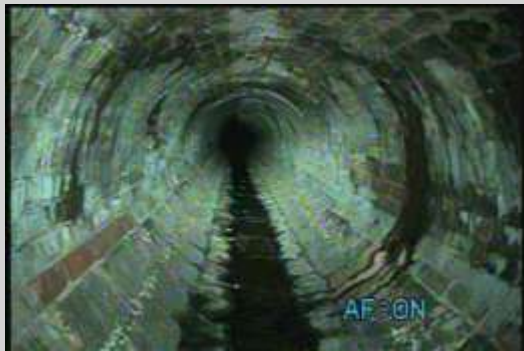
6 O'Clock Inflow

30 in. Circular Gravity Sewer  
Pipe In @ 6 O'Clock

Pipe Material: **Concrete** ☐ Pipe Lined

Invert Depth: **9.30** (ft.) Flow Characteristics: **Slow**

Deposits: ☒ None ☐ Mud ☐ Sludge ☐ Debris ☐ Grease

Infiltration: **None**

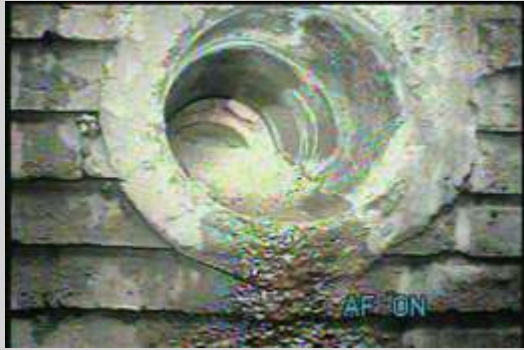
9 O'Clock Inflow

8 in. Circular Gravity Sewer  
Pipe In @ 9 O'Clock

Pipe Material: **Clay** ☐ Pipe Lined

Invert Depth: **3.70** (ft.) Flow Characteristics: **None**

Deposits: ☒ None ☐ Mud ☐ Sludge ☐ Debris ☐ Grease

Infiltration: **None**
